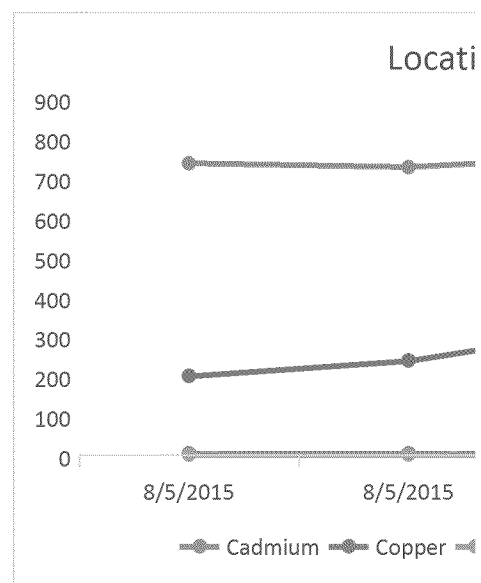
on: A68

Location ID	Date Sampled	Cadmium	Copper	Lead	Manganese	Zinc
A68	8/5/2015	0.828	3.45	0.232	737	199
A68	8/5/2015	0.815	3.16	0.283	727	238
A68	8/5/2015	0.974	3.52	0.82	757	324
A68	8/6/2015	0.85	3.26	0.329	817	326

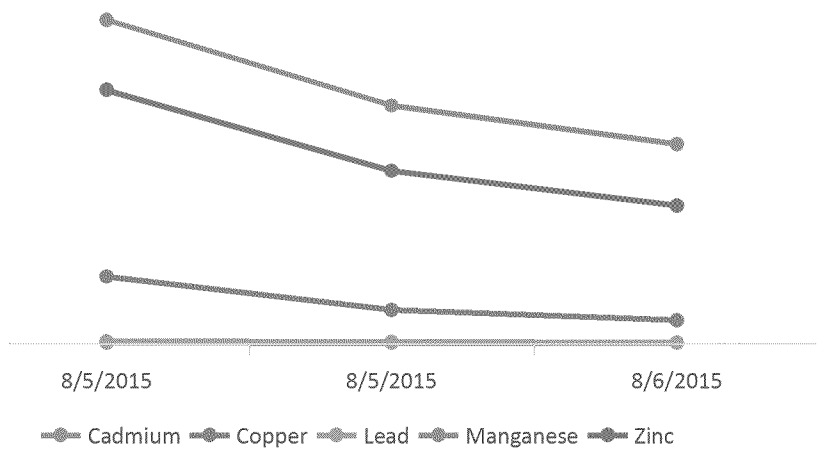
Location: CC48

ocation ID	Sampled	Cadmium	Copper	Lead	Manganese	Zinc
CC48	8/5/2015	30.6	2260	73.9	10900	8540
CC48	8/5/2015	19.1	1130	54.1	8020	5820
CC48	8/6/2015	14.2	786	30	6720	4650
